# WAMASC Rewsletter

#### February 2020

# **BOEING MCAS**

### The Boeing 737 Max 8 MCAS Software problem

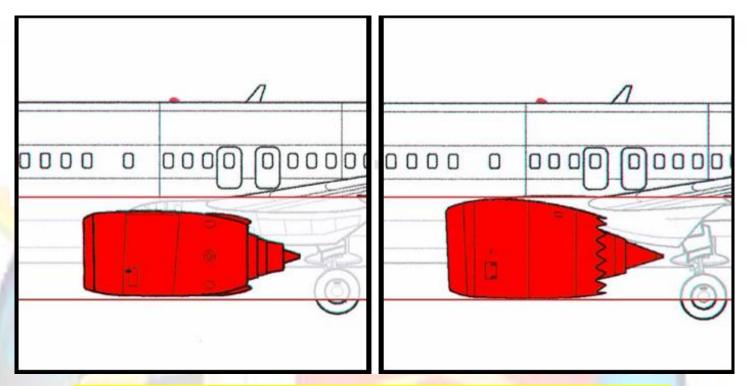
# Engine placement on the third-generation 737 NG (left) versus the MAX (right).

The main problem started with the fitment of new larger and more powerful engines which were too large to fit into the existing nacelles. New pylons and nacelles to hold and support the engines had to be engineered. The new design and manufacture changed the aircrafts **CoG** (Centre of Gravity) and **thrust line** parameters considerably. This in turn changed flight characteristics causing an aerodynamics problem and was the reason a **software upgrade** was placed into **MCAS** to negate (counter) and protect against an inbuilt engineering stall condition – an engineering faux pas with extremely serious repercussion. Especially with the Software glitch that is currently present.

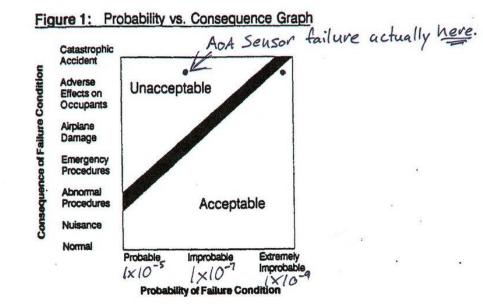
that is inversely-related to its severity. Figure 1, Probability vs. Consequence Graph, illustrates this relationship.

- Minor failure conditions may be probable.
- (2) Major failure conditions must be improbable.
- (3) Catastrophic failure conditions must be extremely improbable.
